Work Package ME8: Antifouling systems for tidal energy devices

Tim Fileman & Tom Vance
Plymouth Marine Laboratory

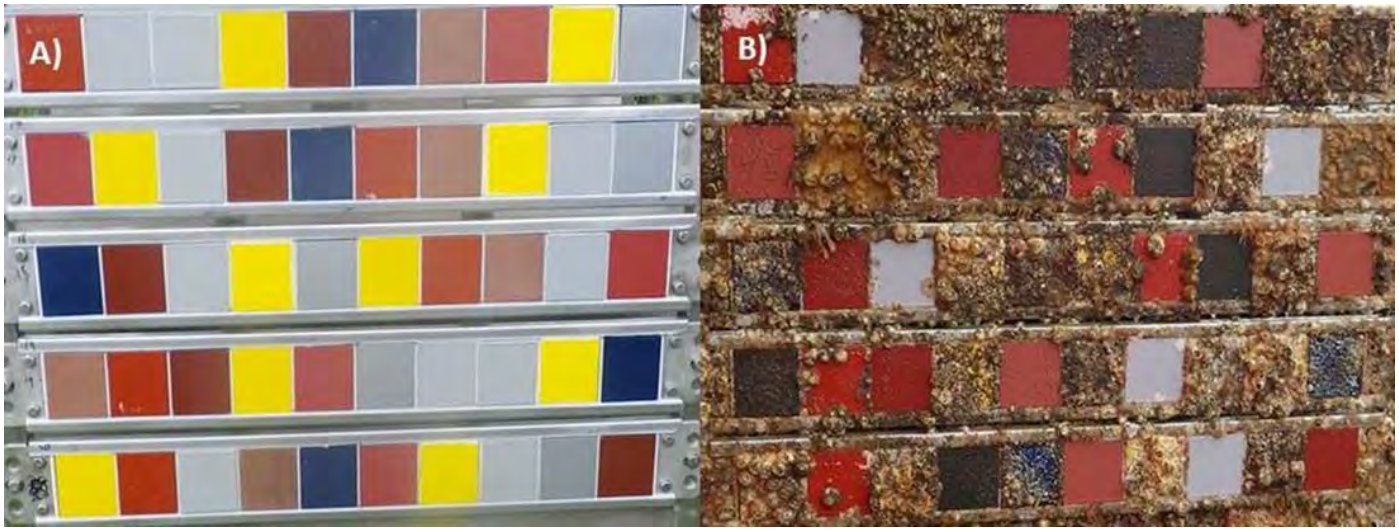
Results: Seabed pod panels May 2014 - 24 months

- Rig intact and all panels recovered
- Clear difference in performance
- Consistent pattern between replicates

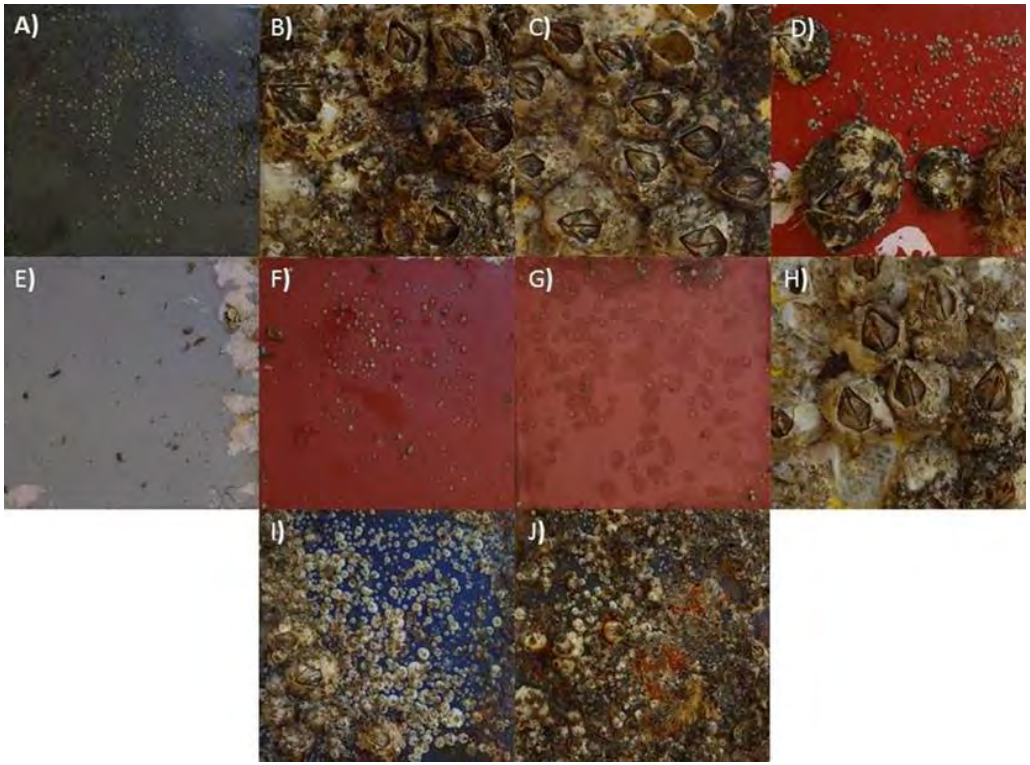
- Fouling assemblage dominated by calcareous species, notably *Chirona hameri*
- Significant damage to coatings caused by growth of individuals

Representative image of the extent of biofouling due to panel coating type. Panel material: A) Coppercoat, B) Ecospeed, C) GRP, D) Hempel Red, E) International Grey, F) International Red, G) Jotun Red, H) Jotun Yellow, I) Pastimo AF and J) Primacon.

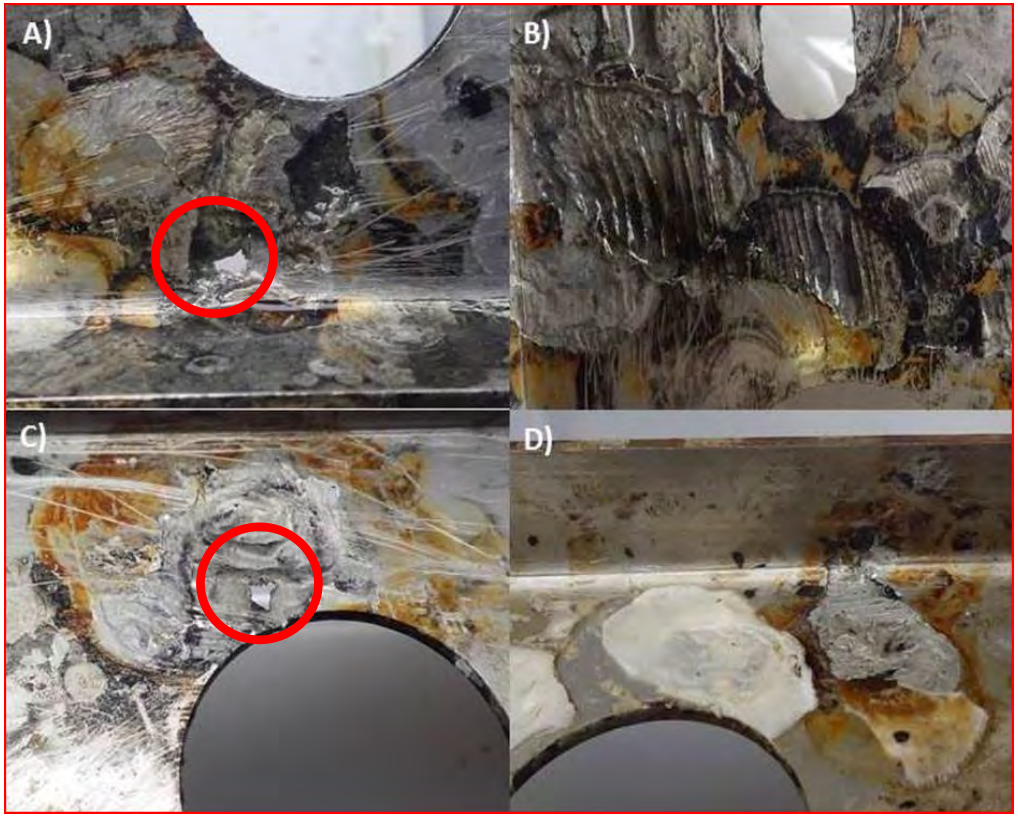
Pit corrosion on 5mm thick 316 marine grade stainless steel after a 24 month exposure in the tidal stream.

- Holes in 5mm & 6mm thick marine grade 316 SS after 2 years
- Approx 3mm loss per year – (Conservative estimate due to barnacle growth not being significant until second year)
- More likely to be …..4mm (or possibly even 5) per year?!
- Bio-corrosion requires more research

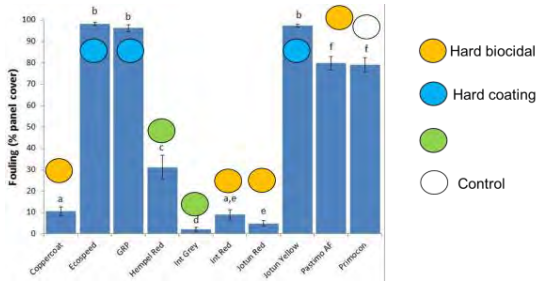
Antifouling performance

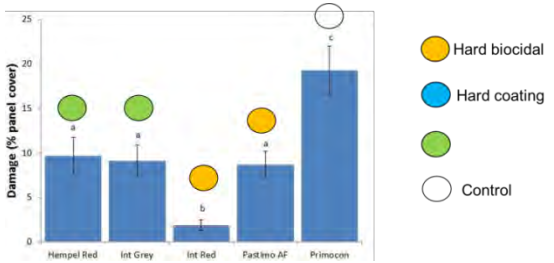
Damage resistance
